King County International Airport Drainage Basin #5

Source Control Report

Addendum 1 – Responses to 1/23/09 Ecology Comments

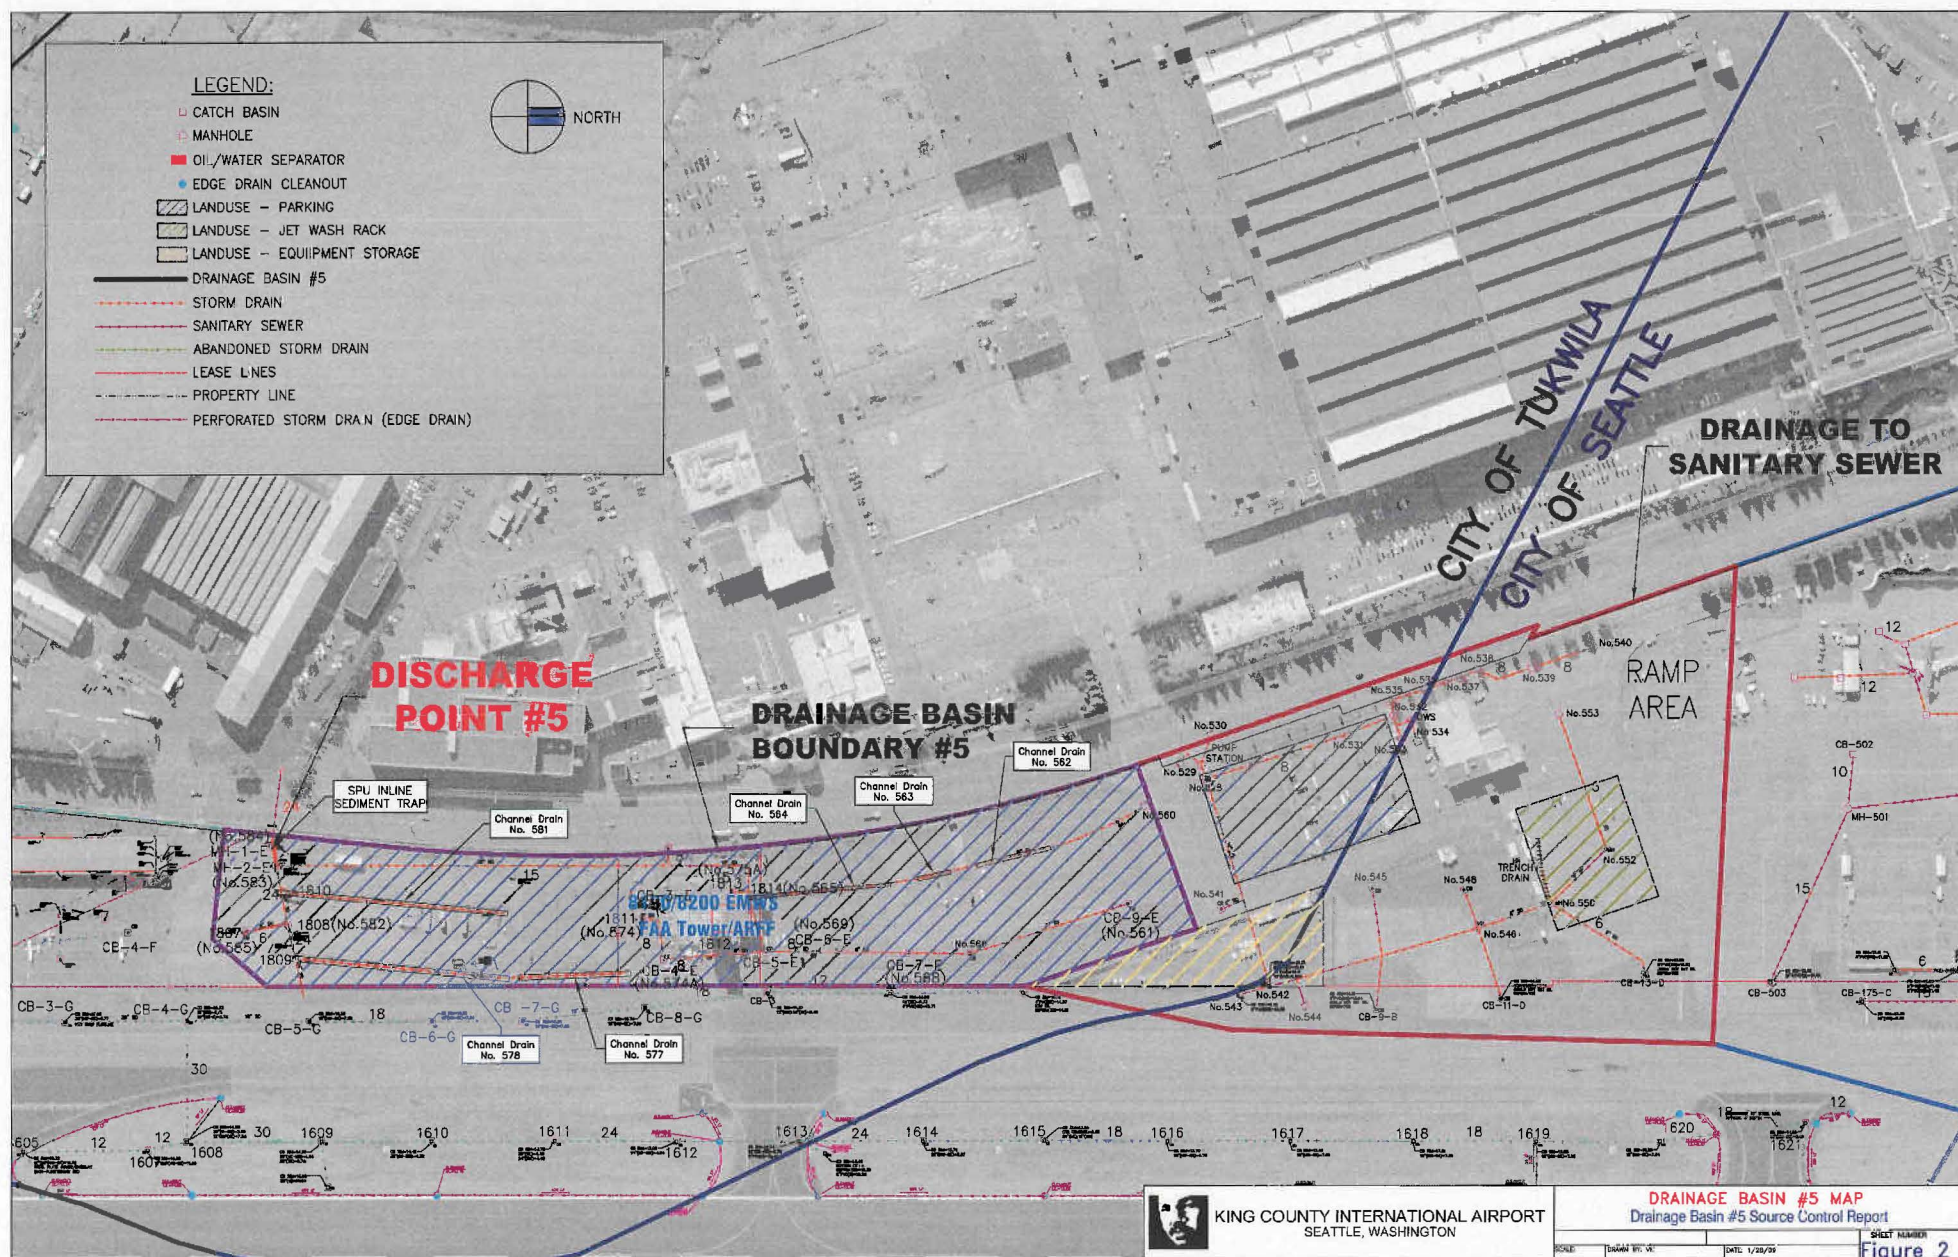
Basin #5 PCB Data Map
Drainage Basin #5 Source Control Report

Comment	Response
<p>At the bottom of the legend the following text appears: CB, PIPE, OR MH CONFIRMED DOES NOT EXIST COULD NOT FIND, UNABLE TO CONFIRM OR DENY EXISTENCE What does this mean? The text is confusing, and there are no key symbols associated with the text.</p>	<p>This legend label was an error and will be removed from Figure 1 and 2. The revised figures are provided in Attachment 1.</p>
<p>Trench drains and channel drains referenced in the text and on Figure 3 are not shown on Figure 2 to be part of the stormwater system/MS4. The purpose of these drains is to collect and convey stormwater runoff; as MS4 features, they must be fully included in the mapping and discussion of Basin 5 (particularly Chapter 5).</p>	<p>Figure 2 was revised to show drainage from the channel drains to the stormwater system. Lines depicting the stormwater lines have been drawn within the channel drains to show their connection to the stormwater system. The revised figure is provided in Attachment 1.</p>

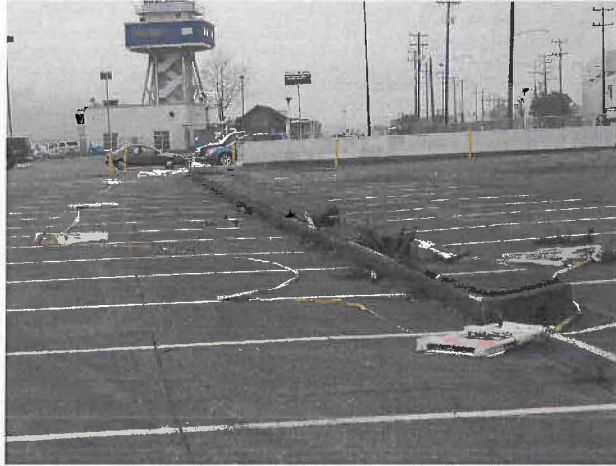
Photo 1. Looking South at Channel Drain No. 562 in NBF lease area.

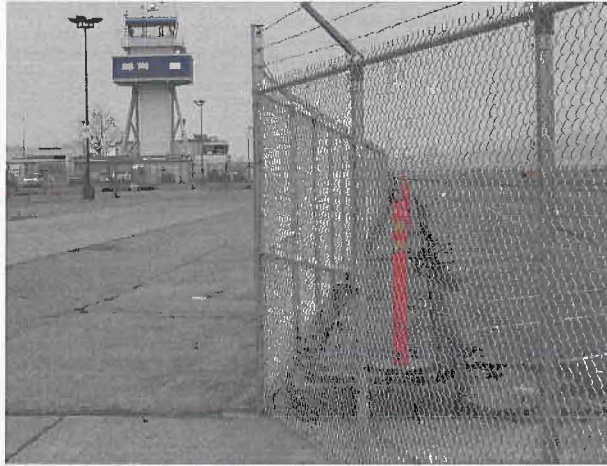
Photo 3. Looking North at Channel Drains No. 578 (foreground) & No. 577 (not shown) in Airport property.

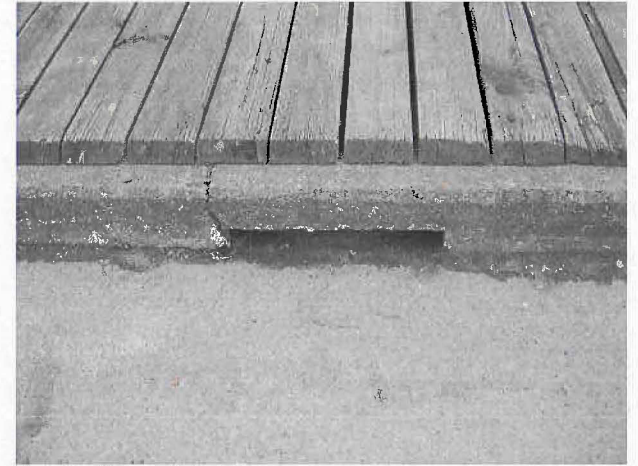
Photo 5. Channel drain inlet.

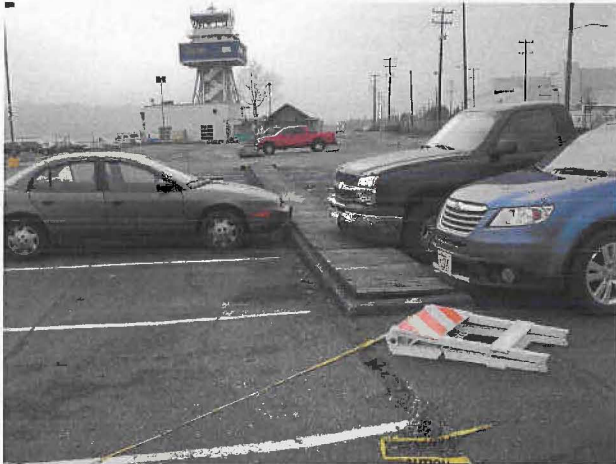
Need to know if "Trench 2" and "Trench 3" is just nomenclature for two sampling points on the same trench, or if these names represent two different trenches. Update mapping to clarify.	Trench 2 and 3 are labels used for sampling points and represent two different channel drains, No. 564 & 563, respectively. See Figure 3 in Attachment 1 .
Regarding point No. 560: this is at the northern end of the Drainage Basin #5 (DB5) delineation. How is this and the rest of the north end of DB5 hydraulically separated from land to the north of the boundary? Is there a berm, curb, or crown (with land to the north sloping downhill in that direction)? When did the northern system get plumbed to sanitary sewer?	<p>A crowned road with curbing separates Drainage Basin #5 from stormwater structures to the north. The stormwater system north of Basin 5 is collected by catch basins and a trench drain which gravity drains, at a southwesterly direction, to the pump station located at the southwest corner of the drainage system. The pump station pumps water to the King County sanitary sewer interceptor located along East Marginal Way.</p> <p>The Airport has requested information from Boeing on when the pump station had been constructed and when it had become operational. This information required additional research. The Airport will convey this information to Ecology as soon as it becomes available.</p>

Photo 2. Looking South at Channel Drains No. 563 (foreground) and No. 564 (at red truck) in NBF lease area.

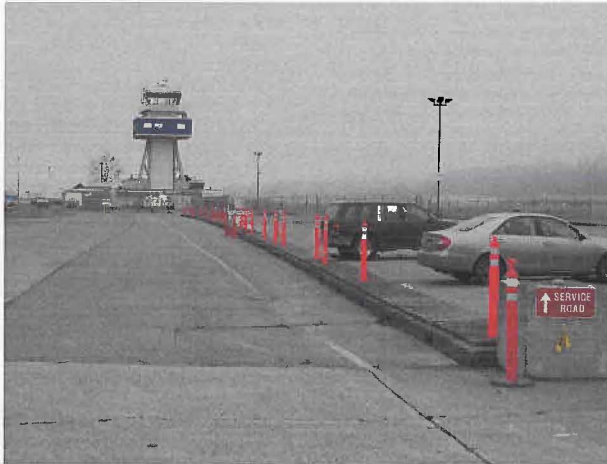
Photo 4. Looking North at Channel Drain No. 581 in Airport property.

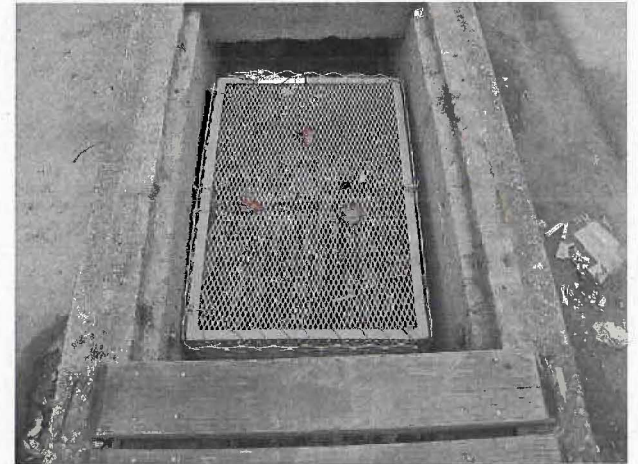
Photo 6. Catch basins located downgradient and inside channel drains
